# Ontario Inspections Inc.

# **Home Inspection Report**

555 Sample Street, Brampton , Ontario, 5Y5 5Z5

Date of Inspection: 11/9/2020 Time: 1:45 pm to 3:55 pm Age of Home: 35 years +/- Size: 2300 Sq ft approx Weather: Sunny 20 degrees, No Rain

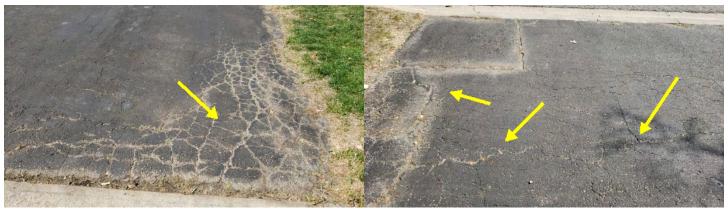
Settlement and common cracking noted.

Common cracks noted.

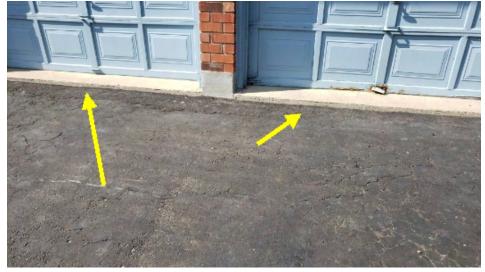
Possible trip hazard. This is a safety concern. Suggest repair/replacement as needed to ensure safety.

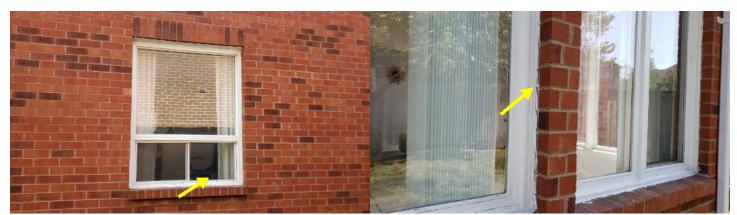
In the inspectors opinion the windows/frames are near the end of their useful life due to the age.

Suggest caulking and refinishing of doors and window frames as necessary.

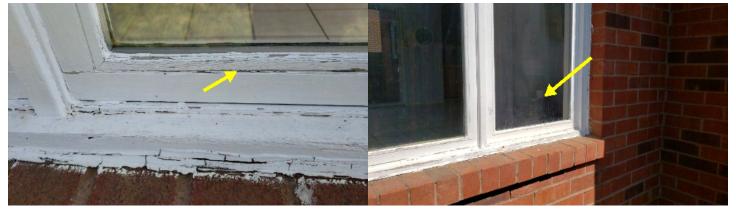
Some windows in this home do not meet modern standards. Upgrade would greatly enhance overall comfort and efficiency.

Fog/condensation observed in Thermopane windows. This is an indication of a failed seal. Recommending review for repair or replacement as necessary.

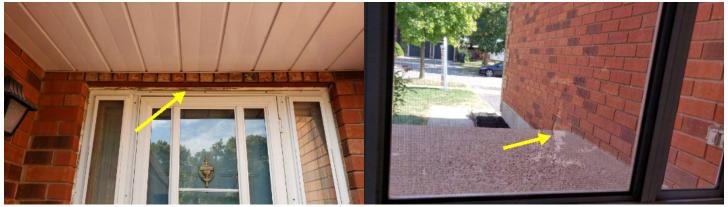
Peeling paint and worn out caulking observed, suggest scraping and painting as necessary.

Wire mesh damage noted.

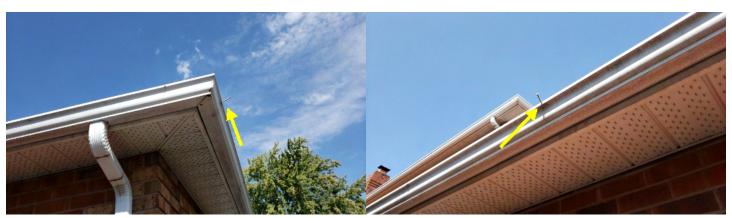
Loose at several areas, suggest securing as necessary.

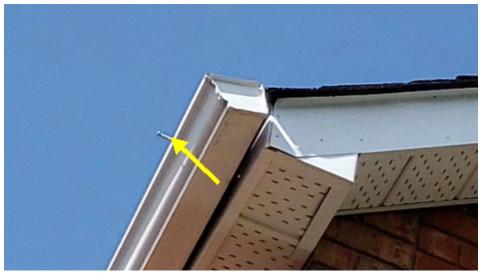
Loose at several areas, suggest securing as necessary.

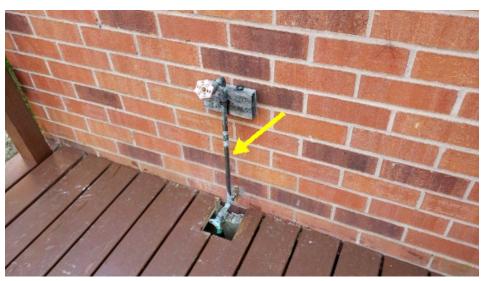
Longer copper pipe noted, could freeze and burst in winter if not winterized. Recommending repair.

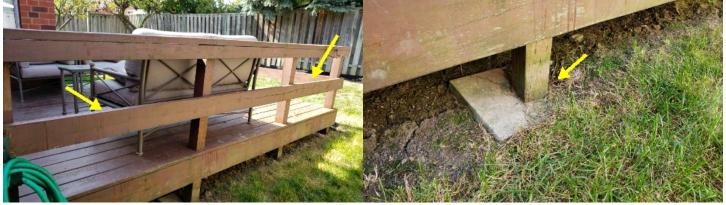
Deck railing is non-compliant as it offers "climbing bars" Recommending replacement by railing with vertical spacing not exceeding 4".

The support posts are not in ground or properly sitting in the footing. Foundation for the deck is tilted causing the structure to lean, Recommending review by a qualified professional for repair or replacement as necessary.

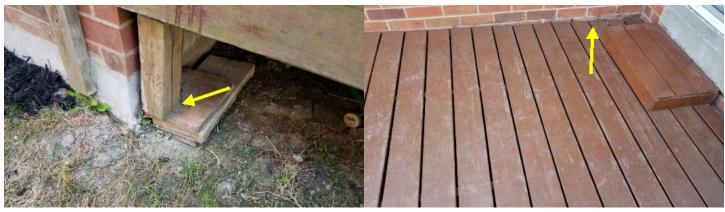
The support posts are not in ground or properly sitting in the footing. Foundation for the deck is tilted causing the structure to lean,

Recommending review by a qualified professional for repair or replacement as necessary, it is tilted.

Recommending review by a qualified professional for repair or replacement as necessary.

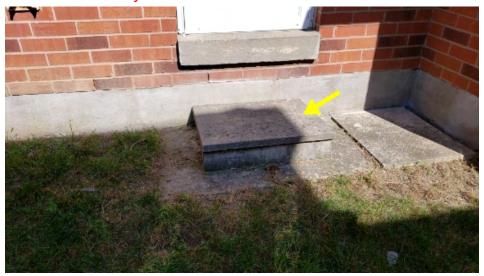
Recommending review by a qualified professional for repair or replacement as necessary as the step is too high.

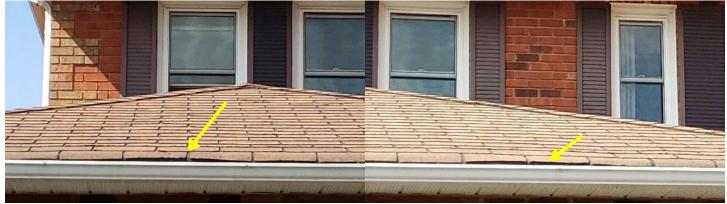
Minor buckling of shingles noted. This is a fairly common condition that is not normally any cause for concern.

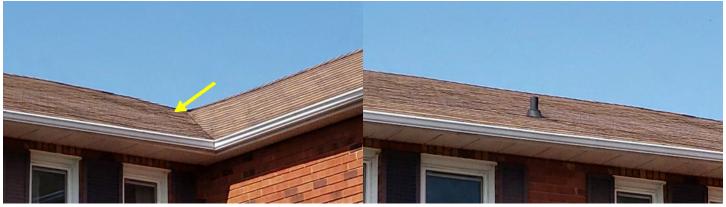
Granular loss and damage observed. Roof appears to be approaching the end of its useful life. Suggest further review by a licensed roofer for repairs/replacement as needed.

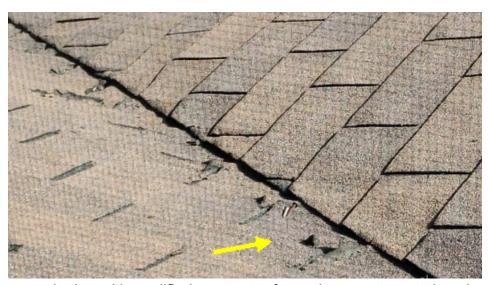
Recommending consultation with qualified contractor for replacement quotations in order to budget.

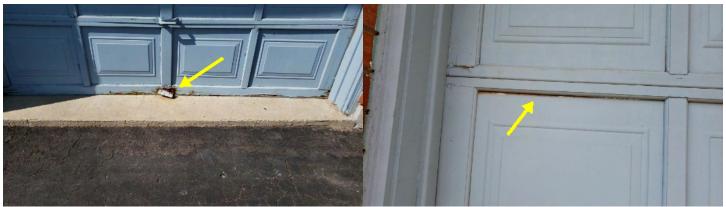
Bottom door panel is water damaged/deteriorated. Damage noted. Recommending review for repair or replacement as necessary.

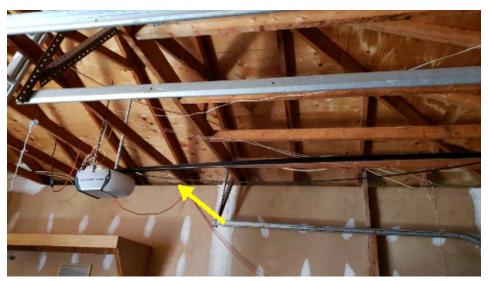
Chain needs to be tightened, Recommend review for repair or replacement as necessary.

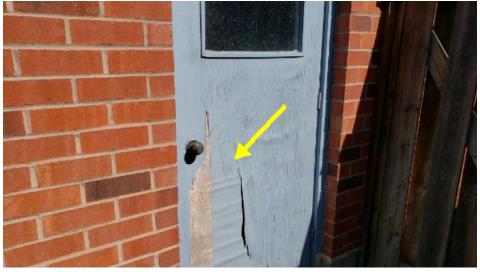
Peeling paint observed, suggest scraping and painting as necessary.

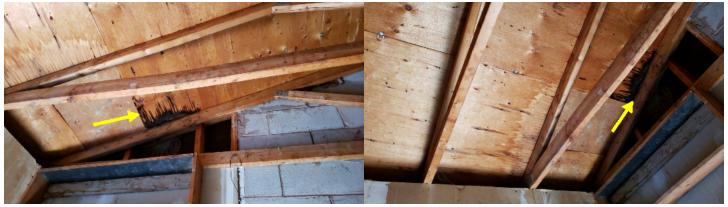
Evidence of past water penetration observed.

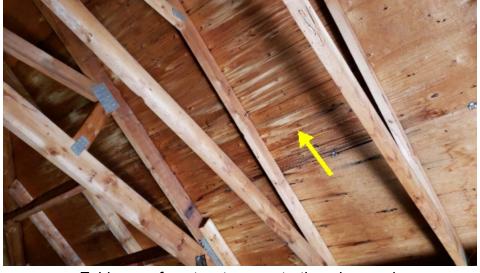
Evidence of past water penetration observed.

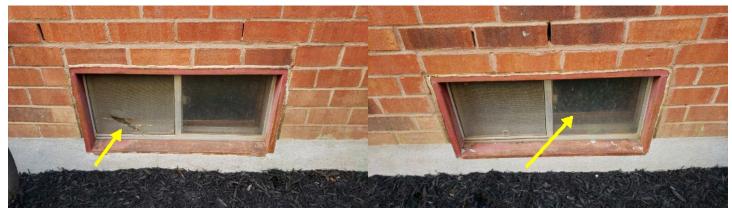
Original windows noted, these windows do not meet modern standards. Upgrade would greatly enhance overall comfort and efficiency.

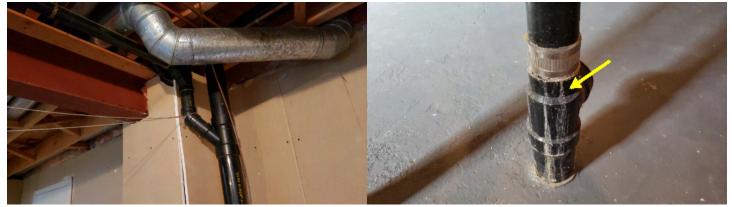
Minor corrosion observed, no leaks visible at time No leaks observed at the time of the inspection. of inspection.

Minor corrosion observed, no leaks visible at time of inspection.

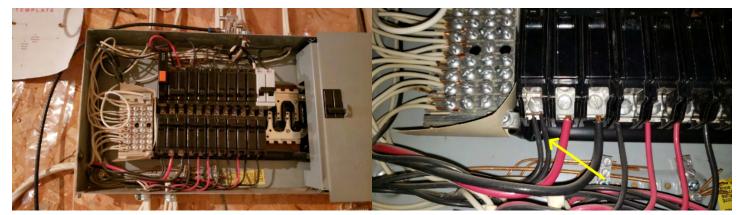
AFCI protection in bedroom branch circuits is a new requirement, not present in this house. Recommending adding as safety enhancement feature.

Double tapping observed. Double tapping (i.e. 2 wires on a single pole breaker) can add to the load of the affected circuit causing a possible overload and tripping breakers, or result in loose connections and overheating of the breaker or connections. Ideally, doubled-up circuits should be independently fused. Repair is recommended.

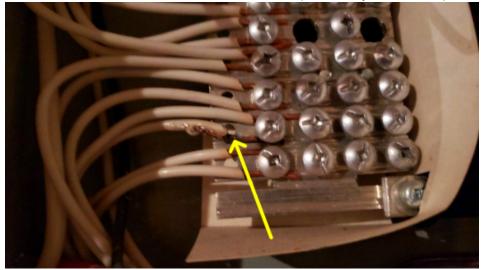
Burned or scorched wiring observed, recommend review by a licensed electrician.

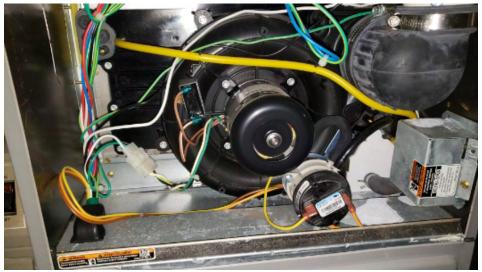
No record of recent service observed. Recommending having this unit serviced for the heating season to prolong the life of this unit.

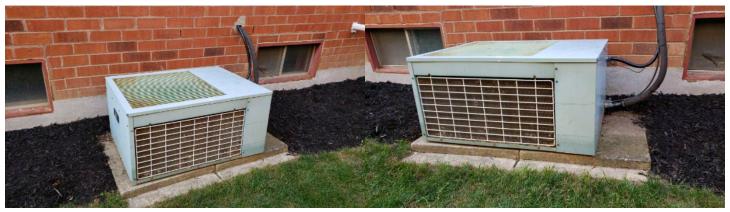
Air conditioning unit was tested and is NOT in the working condition due no cold air, as per inspectors opinion the air conditioner is near the end of its useful life due to age. Replacement is necessary. Client is advised to budget.

The condenser is tilted, excessive uneven settlement can cause fractures in refrigerant line fittings and loss of refrigerant. Unit should be leveled.

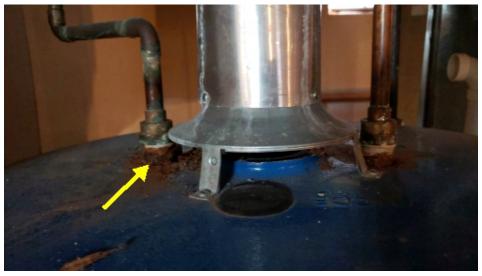
Corrosion noted at fittings.

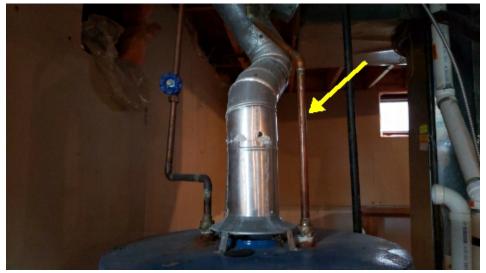
The TPR valve is missing. This is a safety concern. Suggest installing required temperature pressure relief valve as a safety measure prior to closing.

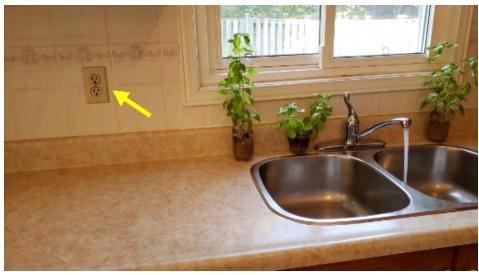
GFCI protected receptacles may not have been required when the house was built. We suggest buyer consider upgrading with GFCI's at all receptacles near water sources.

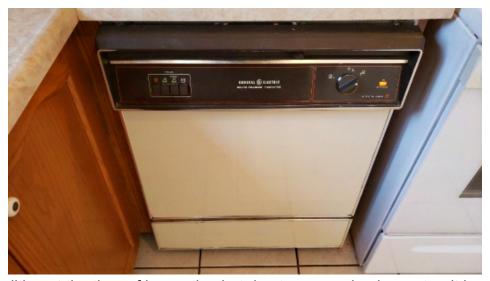
Working condition at the time of inspection but due to age and noisy motor, it is end of its life.

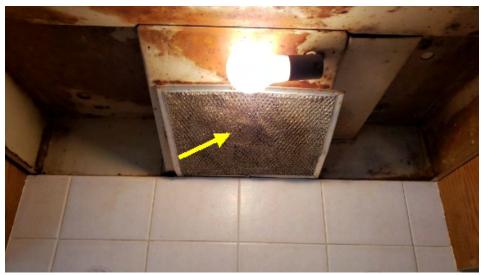
Recommend changing filter due it is touching the fan.

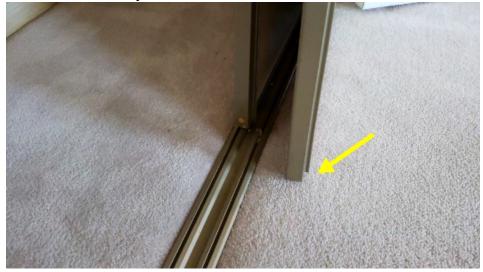
Door does not latch, needs adjustment.

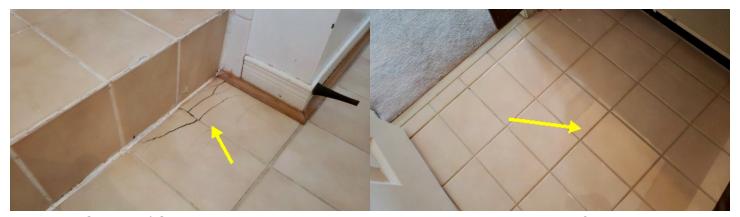
Cracked / Chipped tiles noted.

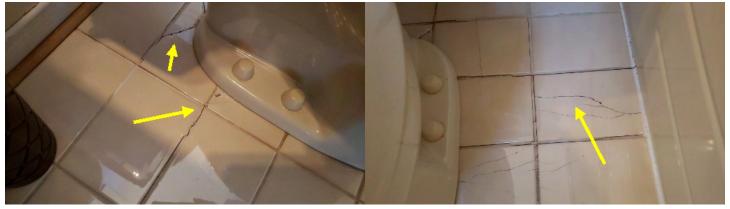
Cracked / Chipped tiles noted.

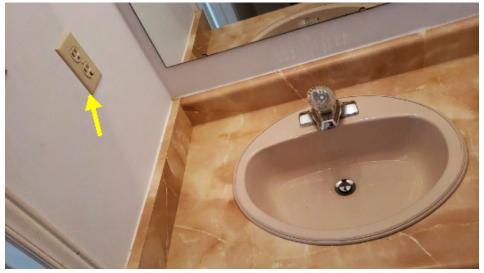
GFCI protected receptacles may not have been required when the house was built. We suggest buyer consider upgrading with GFCI's at all receptacles near water sources.

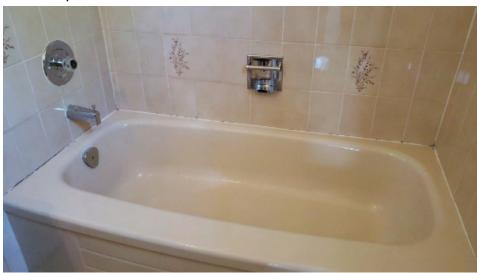
Suggest all tile edges and tub/shower walls be caulked and sealed to prevent moisture penetration.

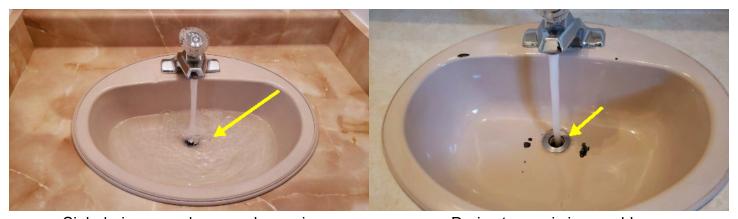
Sink drains very slow, needs repair.

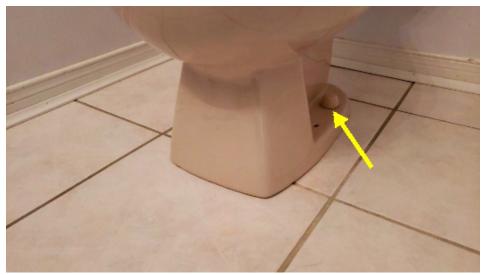
A loose toilet and/or loose/soft sub-flooring was observed. This can indicate damage to the sub-flooring beneath the fixture and floor covering. This condition is not visible or fully accessible to the inspector without destructive investigation. Client is advised to seek further review by a licensed plumbing contractor prior to closing for repairs/replacement as required.

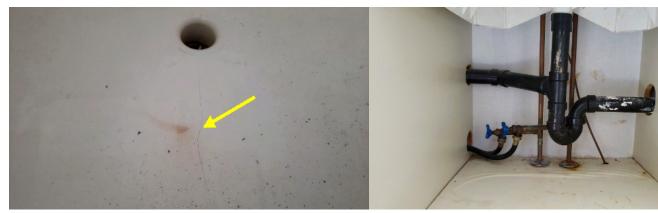
Sink is cracked, Recommend review for repair or replacement as necessary.

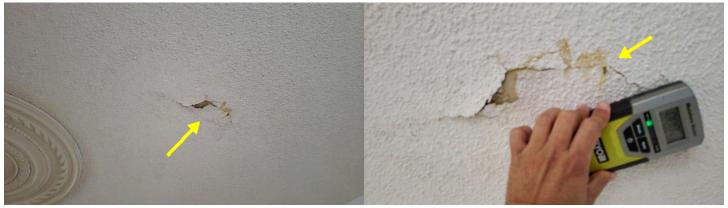
Evidence of past water penetration observed.

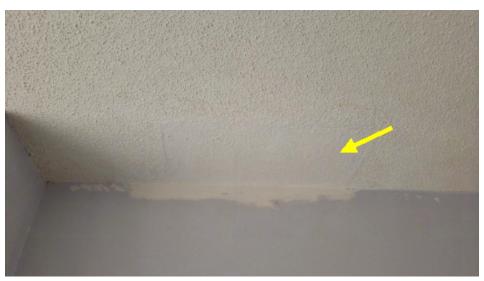
Patching observed.

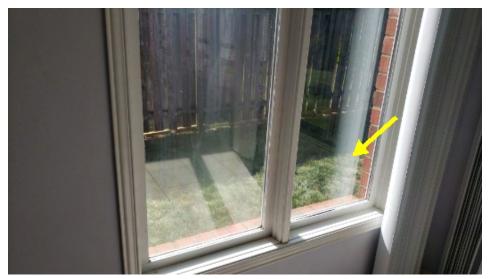
In the inspectors opinion the windows/frames are near the end of their useful life due condensation.

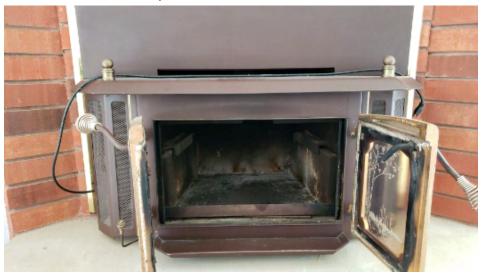
A wood burning fireplace is noted in this home. Please be advised that this item may only be lawfully inspected by a WETT-certified contractor and then, only after a thorough cleaning. It is strongly suggested that this fireplace be cleaned and inspected before close.
