# Ontario Inspections Inc.

# **Home Inspection Report**

555 Sample Street, Brampton , Ontario, 5Y5 5Z5

Date of Inspection: 11/9/2020 Time: 1:45 pm to 3:55 pm Age of Home: 35 years +/- Size: 2300 Sq ft approx Weather: Sunny 20 degrees, No Rain

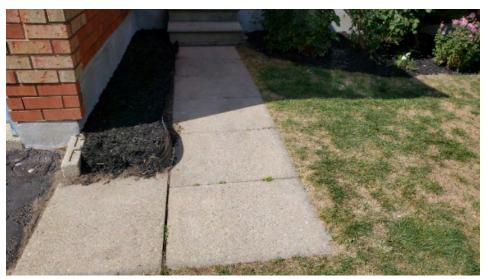
No issues or trip hazards noted.

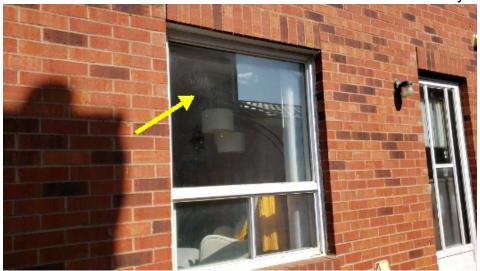
Fog/condensation observed in Thermopane windows. This is an indication of a failed seal. Recommending review for repair or replacement as necessary.

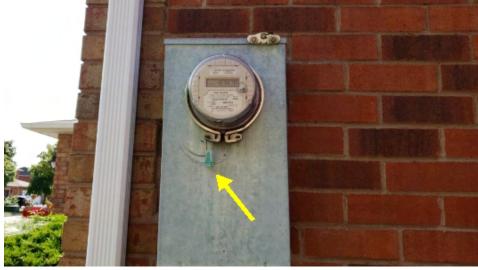
Utility Company Seal observed at the meter.

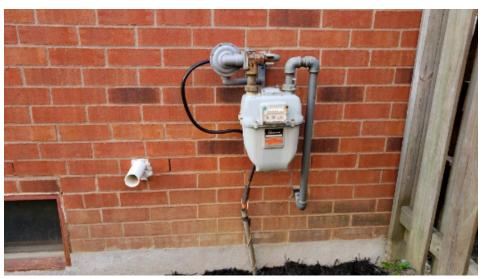
Main fuel shutoff was located at the meter. Checked for any leaks and no odor was detected.

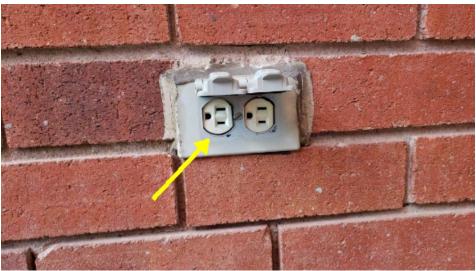
No GFCI protection present, suggest installing GFCI protected receptacles for safety.

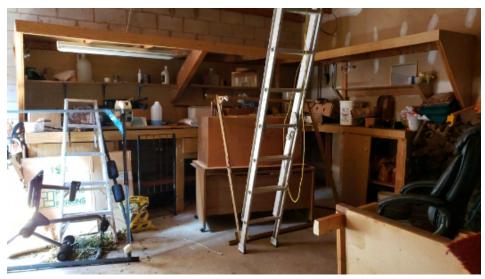
Limited inspection due to storage of personal property.

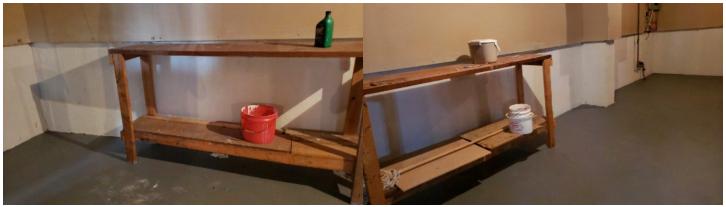
No Damage observed, Dry at the time of the inspection.

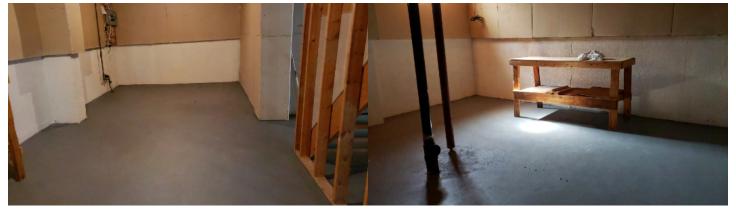
No Damage observed, Dry at the time of the inspection.

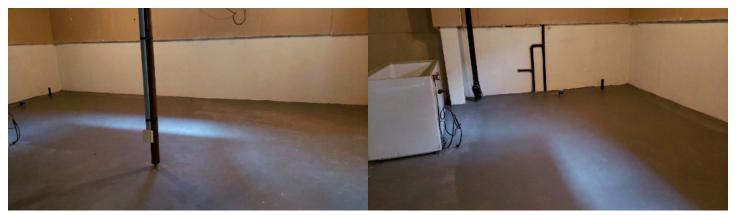
No Damage observed, Dry at the time of the inspection.

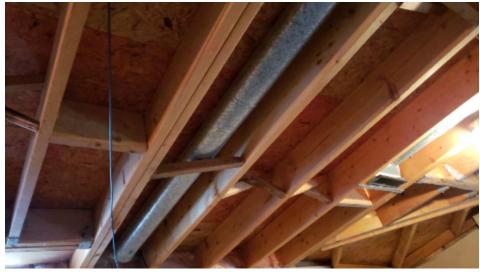
Dry at the time of the inspection. No issues noted, unless specified.

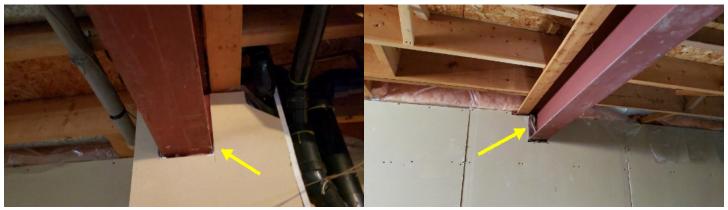
Beams are intact.

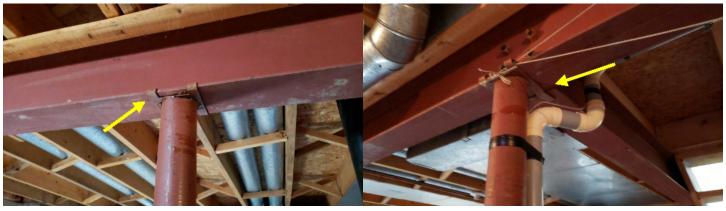
All intact no movement noted.

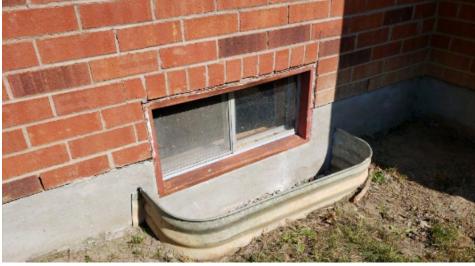
Original windows noted, these windows do not meet modern standards. Upgrade would greatly enhance overall comfort and efficiency.

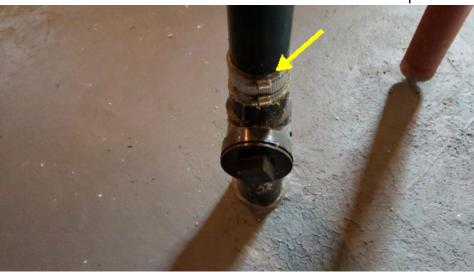
Minor corrosion observed, no leaks visible at time of inspection.

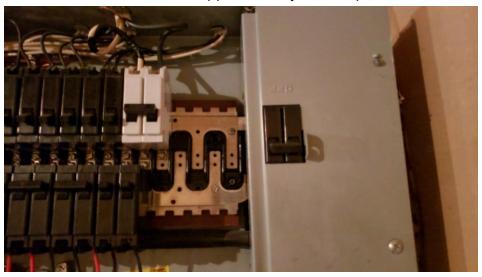
The main service is approximately 100 amps, 240 volts.

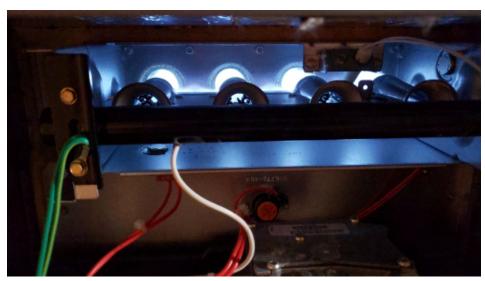
Output 80000 BTU

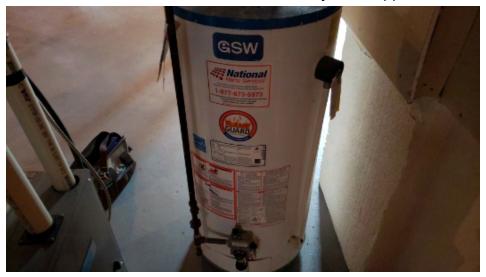
Serviceable and in good working condition at time of inspection. No warranties can be offered on this or any other appliance.

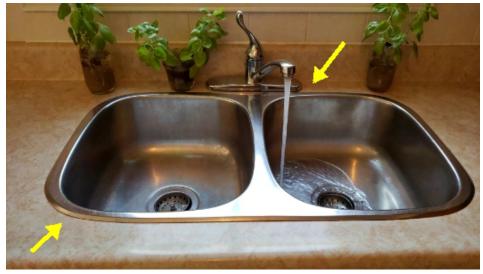
Sink is in good condition, suggesting monitoring of the caulking or sealant all around and near sink areas to avoid any water damage.

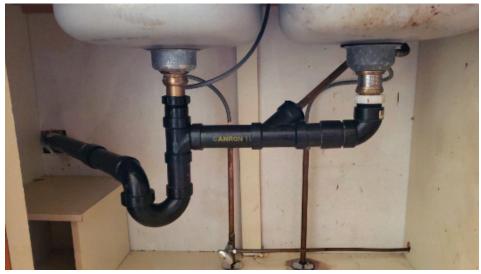
No issues or leaks observed at the time of inspection.

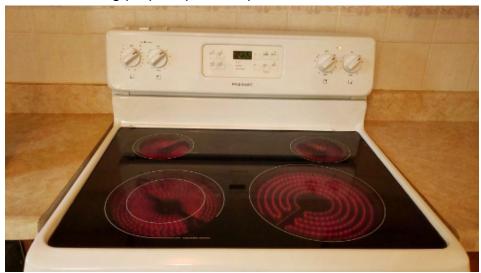
Good working condition at the time of inspection. Recommending confirming proper operation prior to close.

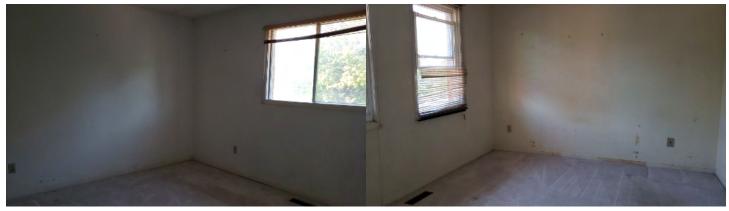
Dry at the time of the inspection. No moisture detected.

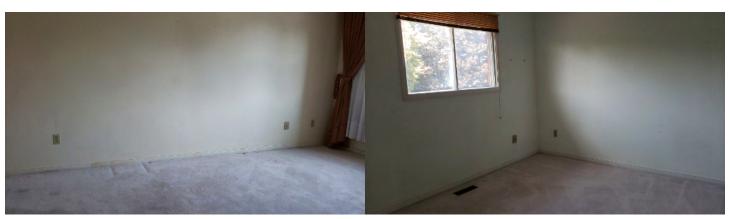
Dry at the time of the inspection. No moisture detected.

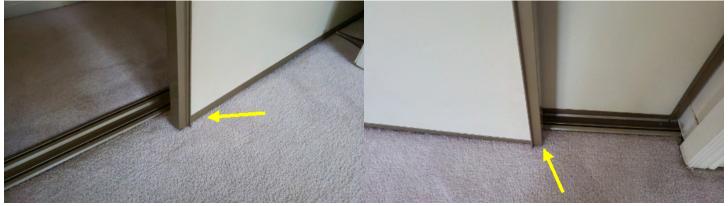
Door does not latch, needs adjustment.

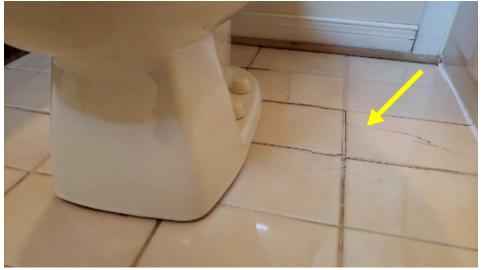
Cracked / Chipped tiles noted.

Recommend review by a qualified professional for repair or replacement, as necessary, prior to close.

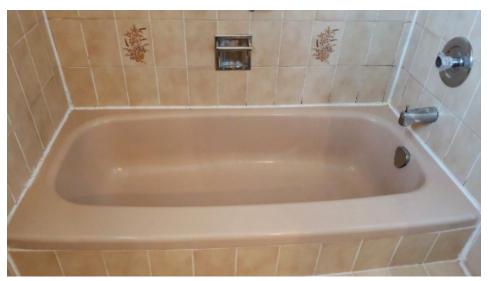
No issues observed, Caulking seems to be in good condition, we recommend monitoring and repairs to be performed if the materials are deteriorating.

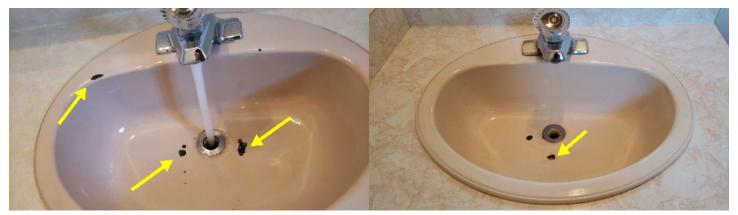
Sink drains very slow, needs repair.

Drain stopper is inoperable.

Sink appears to have been refinished, suggest taking care when cleaning to protect the surface.

Sink needs to be changed due condition.

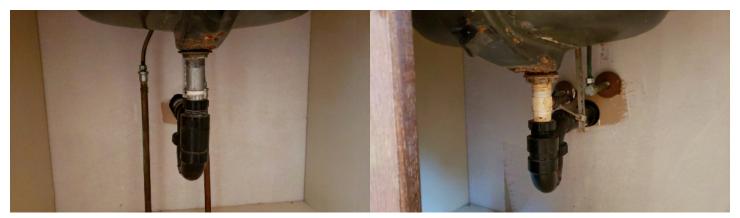
No leaks or issues observed at the time of inspection.

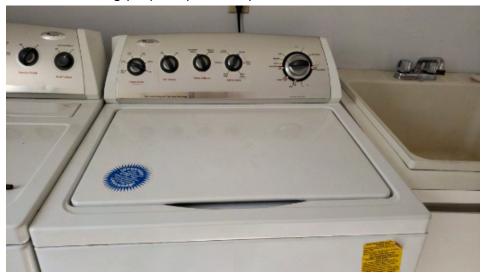
Washer was briefly tested at the time of inspection. We recommend confirming proper operation prior to close.

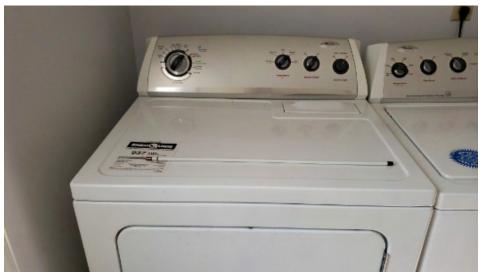
Dryer was briefly tested at the time of inspection. We recommend confirming proper operation prior to close.

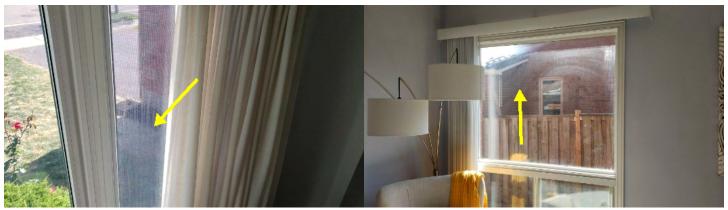
In the inspectors opinion the windows/frames are near the end of their useful life due condensation. near the end of their useful life due condensation.

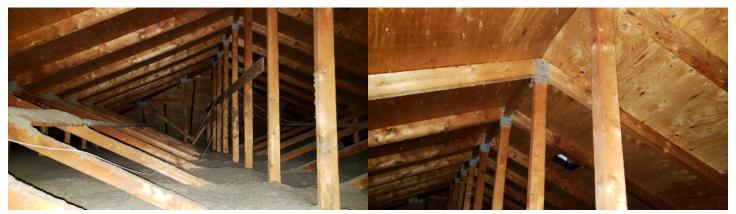
All Intact where visible, No broken or split framing or joints observed at the time of inspection.

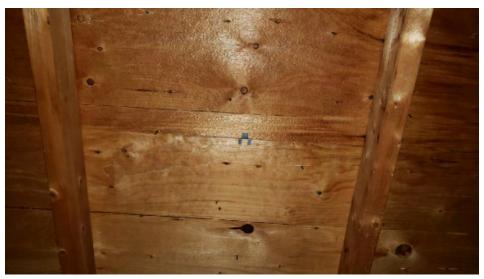
No staining noted, dry at time of inspection.

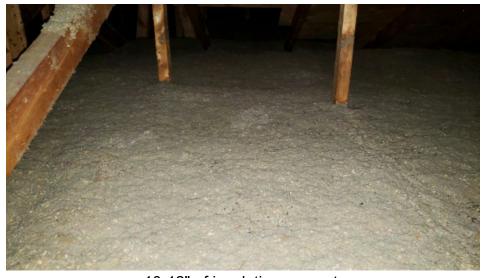
10-12" of insulation present.
